CASE STUDY

Eliason HCG-10 ABS Impact Traffic Door

Pizza Crust Manufacturing Facility

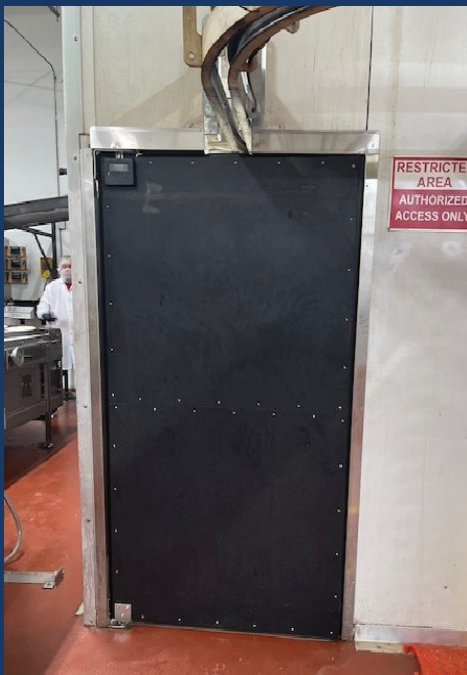
BEFORE

The existing Chase door had performed exceptionally well, operating reliably for more than 10 years in a high-impact environment with carts passing through every 30–45 seconds, at times across two continuous shifts. However, as production demands evolved, the application revealed an opportunity for a more optimized solution. While the original door proved durable, it was not specifically designed for the intensity and unique conditions of this opening, and its size was not ideal for achieving optimal sealing and overall performance.

The harsh environment—marked by heat and humidity from the oven—required a solution better suited to withstand these extremes, while constant high-frequency traffic created ongoing wear on hinges and gasketing, highlighting the need for a more robust, impact-resistant design. Although the facility initially considered replacing only hinges and gaskets, this limited approach would not have fully addressed the broader performance needs.

Based on these insights, an Eliason HCG10 door was selected for its heavy-duty construction, ability to withstand constant high-frequency impact, and proper fit for the opening, improving both workflow and environmental separation. The door was equipped with an Easy Swing hinge to ensure durability and smooth operation in a high-cycle environment, along with armor reinforcement to protect against frequent cart impacts.

A right sized door eliminated common wear points while still maintaining performance in heat and humidity, and the existing frame was reused to enable a seamless, efficient installation by the facility team.
